Manhole Inspection Summary

Manhole # S15AA_002MH

Insp Date: **5/6/09 1:23 PM**

Location Address: **926 ASHBURTON ST**

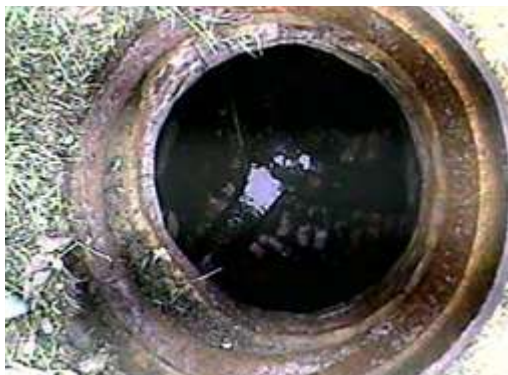
Offset: **3** (in.)

FRAME OFFSET

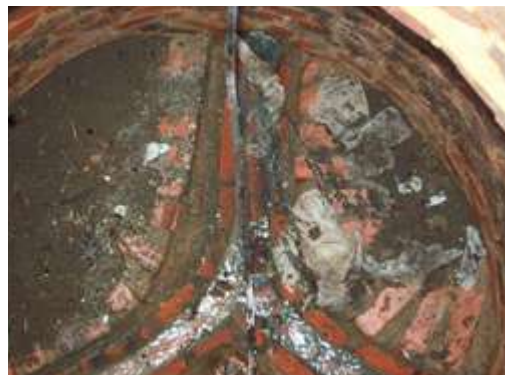
Defect 3

Condition: ☐ Sound ☐ Cracked ☐ Root Intrusion ☐ Deteriorated ☐ Leaks ☒ **Debris**

DEBRIS IN CHANNEL AND ON BENCH

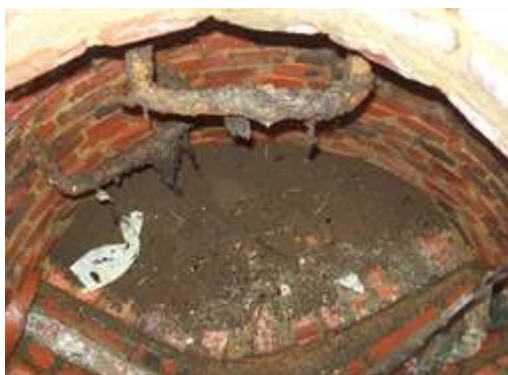
Defect 2

Count: **2** Missing: **0** ☒ **Corroded**

CORRODED STEPS

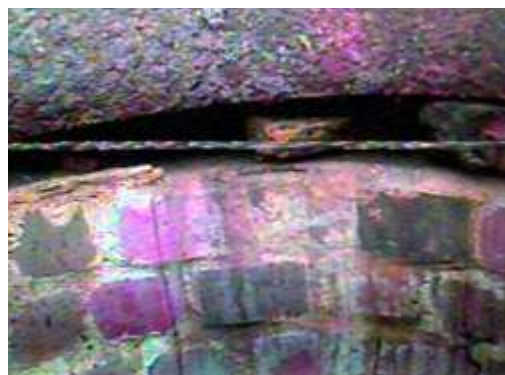
Defect 1

Condition: ☐ Sound ☐ Cracked ☐ Root Intrusion ☒ **Loose Brick** ☐ Deteriorated

CHIMNEY/ADJUSTMENT-LOOSE BRICKS

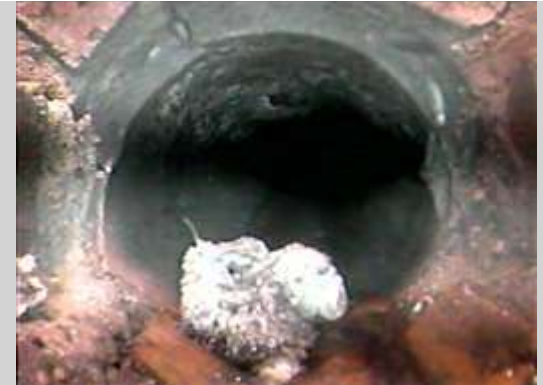
12 O'Clock Outflow

8 in. Circular Gravity Sewer
Pipe Out @ 12 O'Clock

Pipe Height: (in.) Direct
Pipe Material: **Clay** ☐ Pipe Lined
Invert Depth: **6.72** (ft.) Flow Characteristics: **Slow**
Deposits: ☒ None ☐ Mud ☐ Sludge ☐ Debris ☐ Grease
Silt Depth: (in.) Deposits Extent:
Infiltration: **None** Pipe Seal Cond: **Sound**

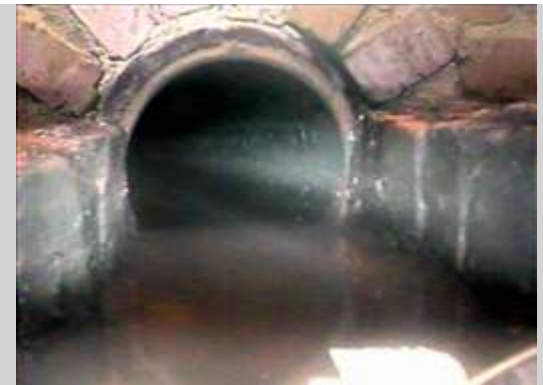
3 O'Clock Inflow

8 in. Circular Gravity Sewer
Pipe In @ 3 O'Clock

Pipe Height: (in.) Direct
Pipe Material: **Clay** ☐ Pipe Lined
Invert Depth: **6.58** (ft.) Flow Characteristics: **Slow**
Deposits: ☒ None ☐ Mud ☐ Sludge ☐ Debris ☐ Grease
Silt Depth: (in.) Deposits Extent:
Infiltration: **None** Pipe Seal Cond: **Sound**

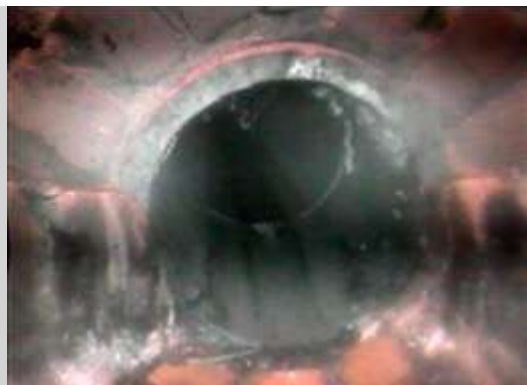
7 O'Clock Inflow

6 in. Circular Gravity Sewer
Pipe In @ 7 O'Clock

Infiltration: **Evidence** Pipe Seal Cond: **Sound**
